Evaluation and Validation of the Causes for Cobblestone Road Failures in Hawassa City

Abstract

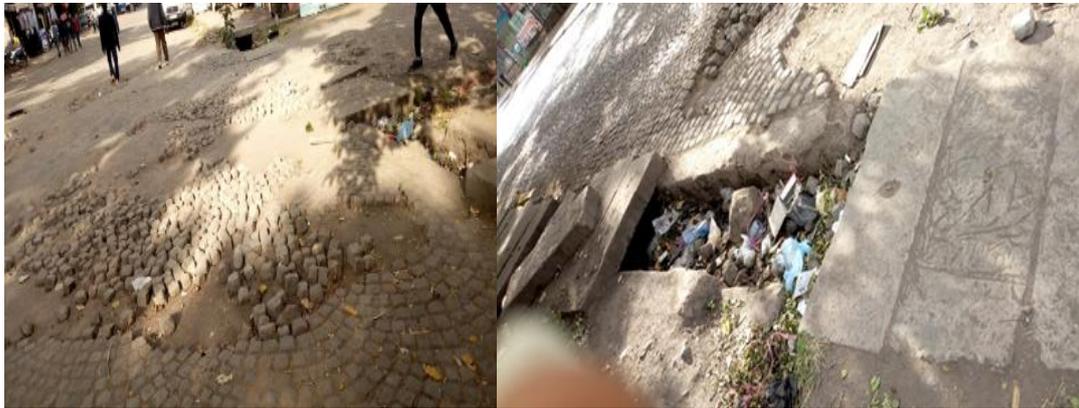
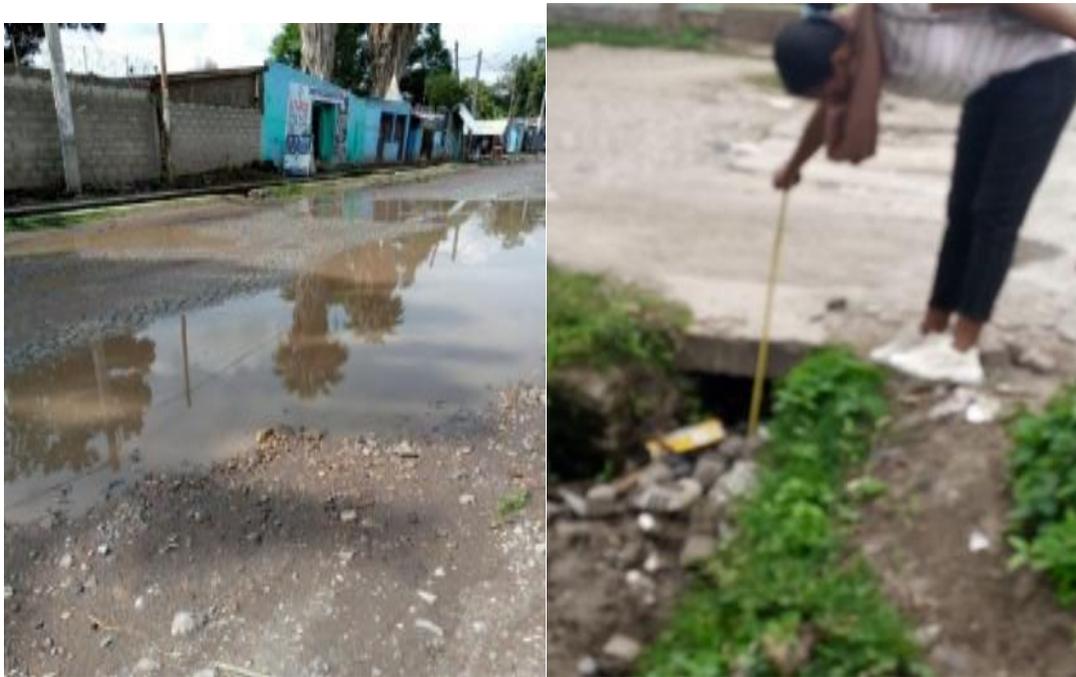
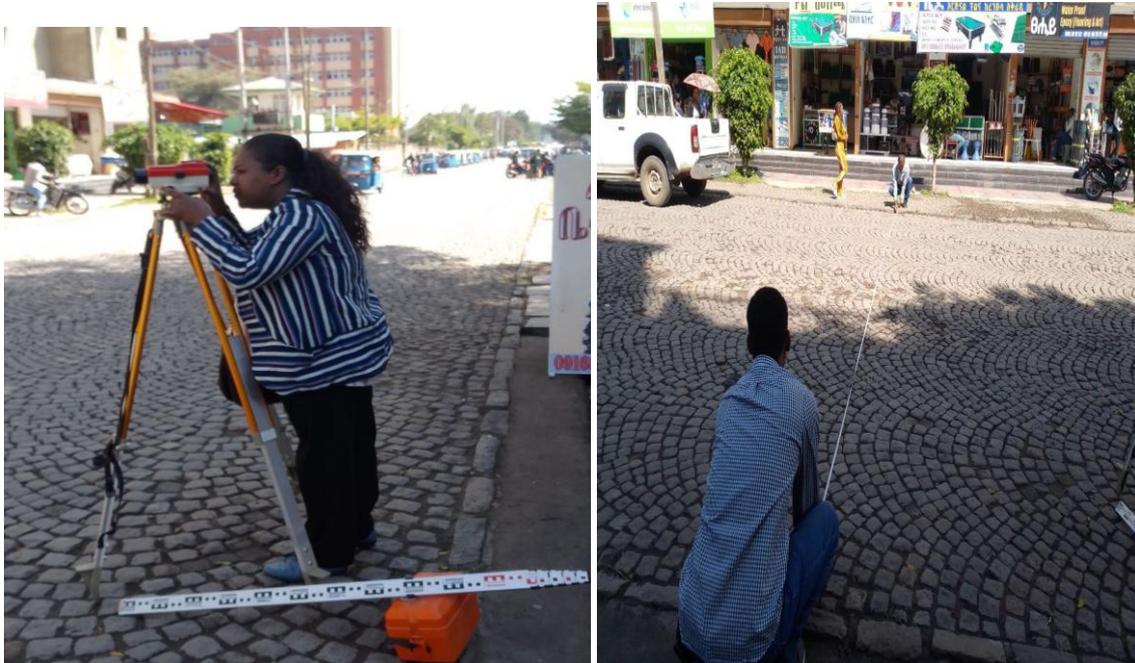
Figure 3. Failure pictures on the study area

The type of failures that observed in the study area are lifting of cobblestones, surface depression and failure of cobblestone edging.

The observed failures on the study area cobblestone roads during the research are poor drainage, lack of bonding and carriage way slope.

If the deterioration type of a given route is lifting of cobblestones to correct the route first lift out cobblestones in demarcated area and then clean the bed, lay down a layer of clean graded sand and compact, and lay new cobblestones. If the deterioration type is surface depression lift out cobblestone in demarcated area, clean the bed, add sub-base material and compact, lay a sand bed and compact and then lay new cobblestones. If the deterioration type is failure of cobblestone edging lift out cobblestone in demarcated area, clean the bed, add sub-base material if required and compact, lay a sand bed and compact then lay new cobblestones.

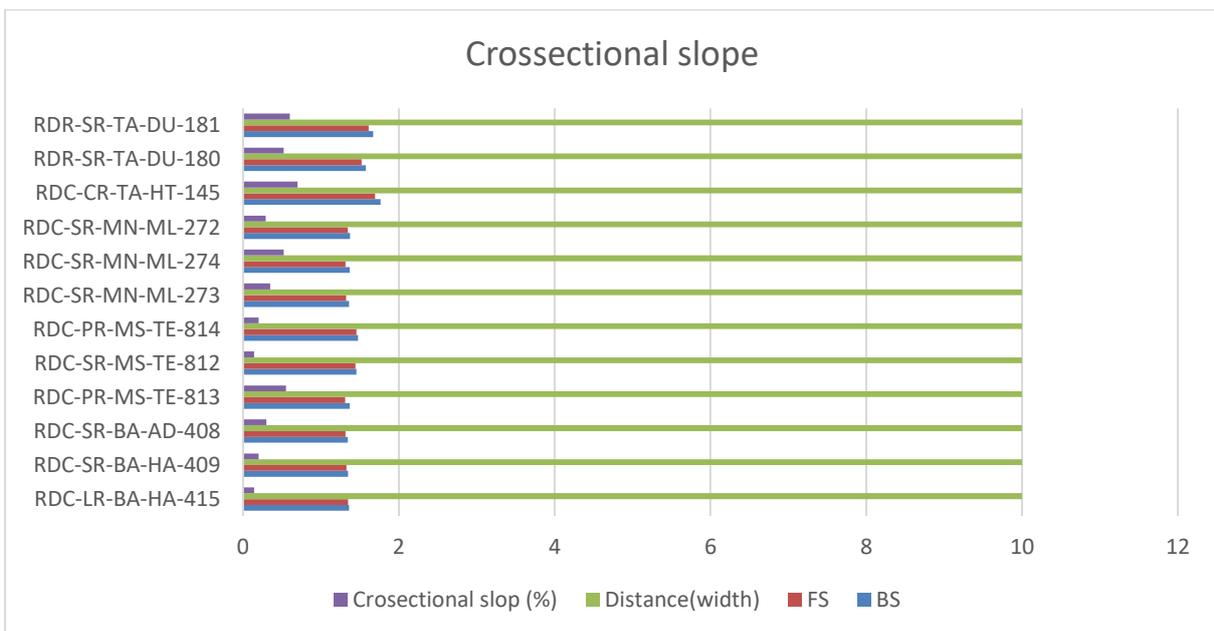
Figure 5. Cross-sectional slope condition

The carriage way slope for the routes taken from Bahil Adarash subcity is 0.14%,0.2% and 0.3 % and the misrak subcity 0.55%,0.14% 0.2% for menehariya sub city 0.35%,0.52% and 0.29% for Tabor sub city 0.7%,0.52% and 0.6% (Chart 3.3) which all doesn't attain the recommended standard.
