## **Investigation of Conservation and Restoration Practices for Historical Buildings in Arada Sub-City, Addis Ababa, Ethiopia**

**Keywords:** Heritage conservation, Historical buildings, Restoration processes and practices, Cultural heritage management, Ethiopia.

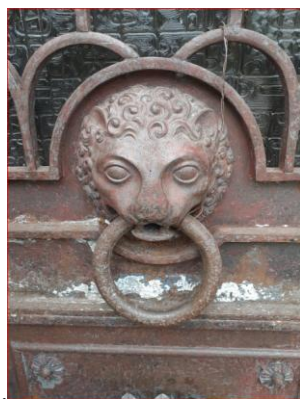
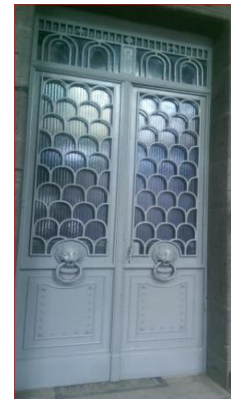
Figure 2: The status of the door of the building before, during and after restoration work

A) Rusted door

B) Firing process

C) Painted door

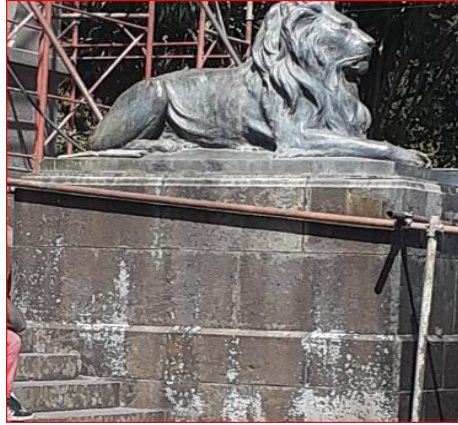
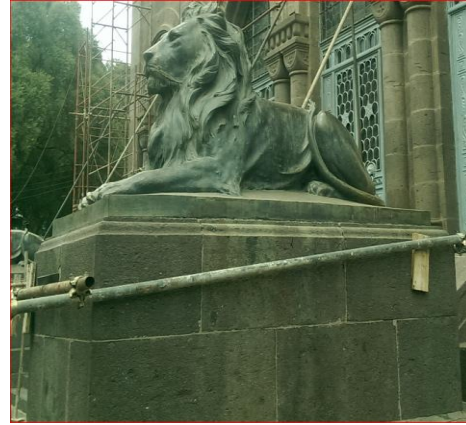
*Figure 3: The status Lion monument with its support masonry wall*

A) Lion monument before restoration work

B) Lion monument after restoration work

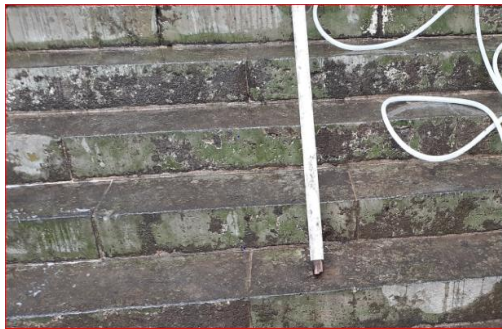
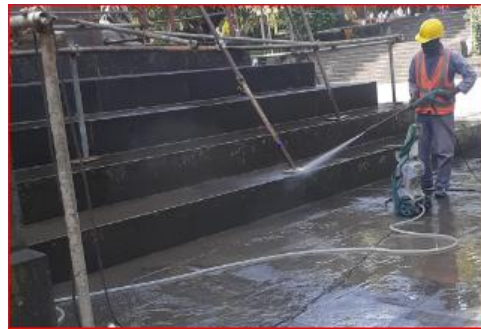
*Figure 4: The status of the external staircase*

A) Algae and fungi colony on external staircase

B) cleaning work on external staircase

Restoration work began at the end of 2011 EC with a contract amount of 16.7 million ETB, involving Misac General Contractor, Fasil Giorgis Consultant, the Ethiopian Orthodox Church, and supervision by Addis Ababa City Administration Culture & Tourism Bureau. The restoration process involved cleaning and repainting walls, maintaining 16 steel-alloy doors, and covering broken windows with canvas paintings due to unavailability of original glass (Alamy Stock Photo, 2020). For example, the eight copper lion monuments and their supporting masonry walls were cleaned to remove corrosion, salt efflorescence, and fungal colonies, while cracks in the masonry were plastered, preserving their historical and cultural value. External and internal staircases were cleaned and repaired due to algae, fungi, and smoke damage. The

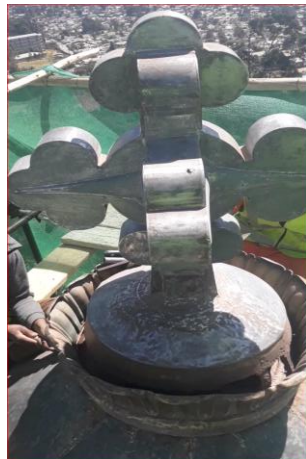
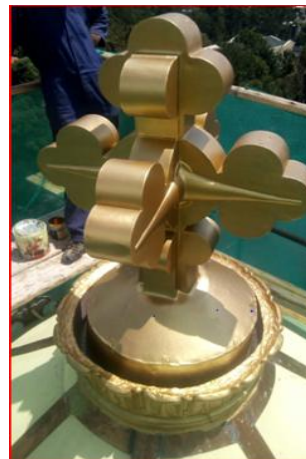
*Figure 5: Upper cross before and after restoration work*

A) Deteriorated cross surface

B) painted cross surface

top structures of the church, including the cross, crown, and cast-iron pillars, were heavily corroded because of poor drainage, requiring full restoration, welding, and repainting (Alamy Stock Photo, 2020).

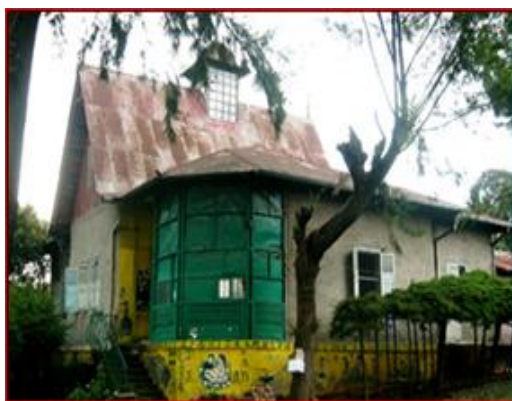
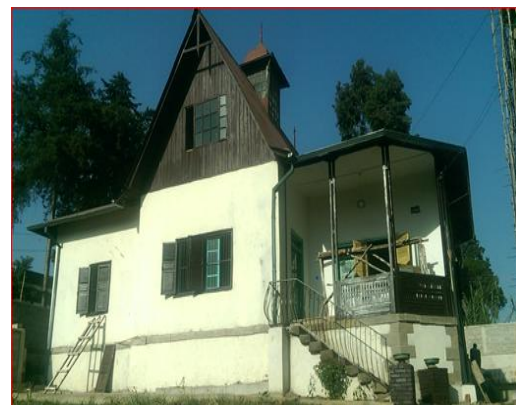
*Figure 6: The status of Teshome Berhe Residence*

A) External part of the building before restoration    B) External part of the building after

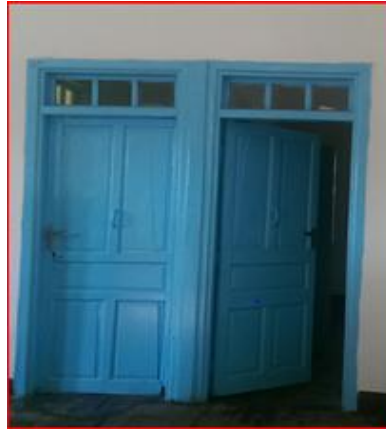
*Figure 7: Doors and windows of the building after restoration work*

A) Well Maintained door

B) well-maintained window

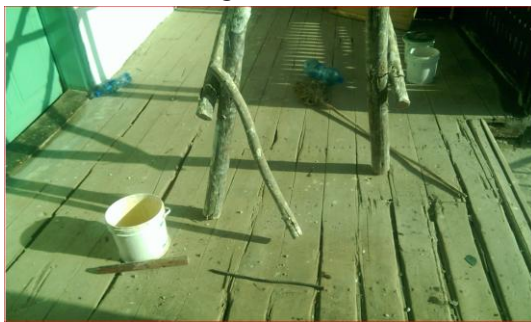
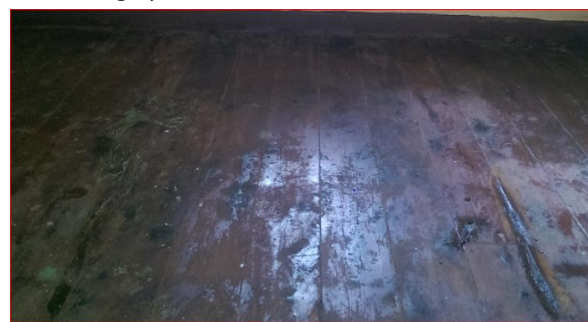
*Figure 8: Timber floor finish before and after restoration work*

A) Deteriorated floor finish

B) Well-maintained floor finish

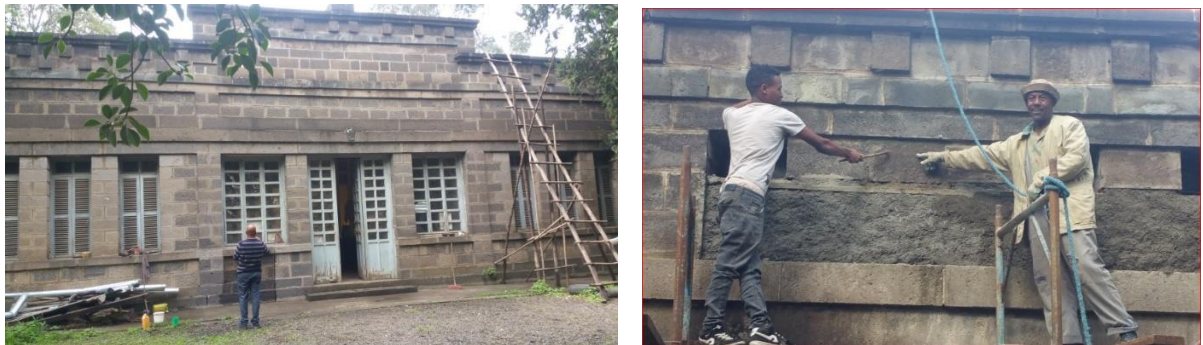
Figure 9: The upper part of the external wall during restoration work

The restoration process started with detailed investigation and research to identify the root causes of deterioration. The stone walls, affected by aging and algae/fungi growth, were partially reconstructed, cleaned with detergent, and treated with Sikagard chemical to improve water resistance and stain protection. Wooden doors and window frames, deteriorated due to dampness, aging, and insect activity, were repaired or replaced, and broken glass was

substituted with new panes. The roof sheets were corroded and replaced to prevent water infiltration, and the brick-and-mortar chimney, which had developed cracks, was reconstructed and plastered (Figures 9–11).

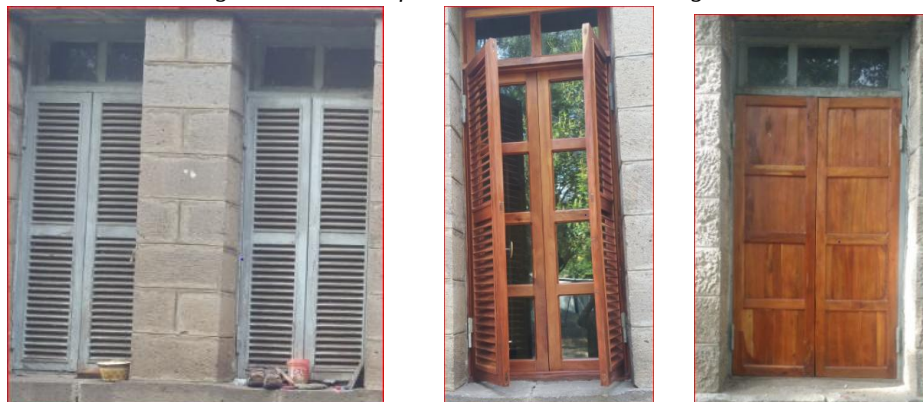
Figure 11: Windows of the building before and after maintenance

A) Deteriorated window frames B) Windows of the building after maintenance

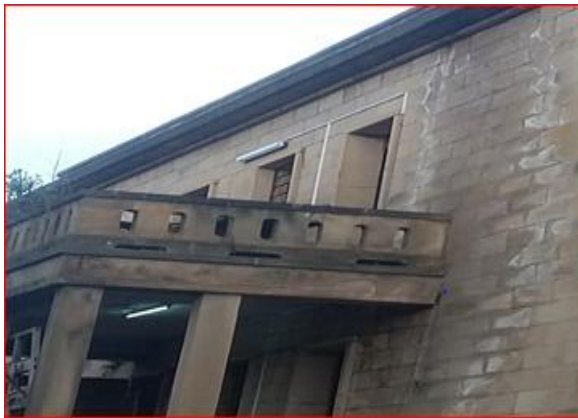
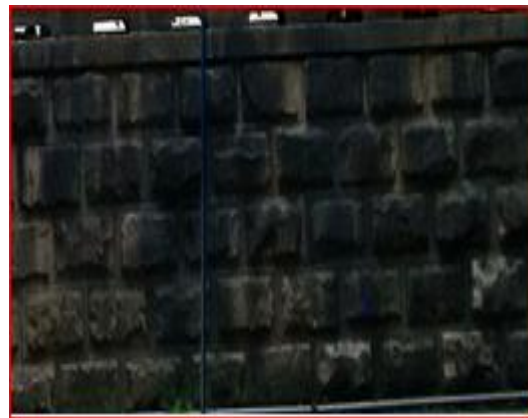
*Figure 13: Deteriorated external wall surface*

A) Efflorescence effect on the surface of the wall

B) Algae colony on external wall surface

The restoration process included a comprehensive investigation and documentation by conservation experts from ARCCH. The walls, damaged by algae, fungi, missing render, efflorescence, and minor cracks, were cleaned, repaired, and repointed. Internal walls affected by roof leakage were dismantled, re-plastered with gypsum, and painted. Metal and wooden doors and windows, deteriorated due to aging, dampness, and insect activity, were repaired or replaced, and broken glass and missing locks were restored. External stone staircases affected by algae growth and minor cracks were washed and repointed. The slab roof, a major source of internal dampness, underwent extensive restoration: damaged tiles were removed, a waterproof membrane applied, and tiles reinstalled. Internal timber and marble floors, damaged due to uneven load distribution, were replaced or repaired, while external floor finishes on balconies and verandas were entirely replaced with nearly identical materials (Figures 12–16). Two major challenges were observed during the restoration. First, although the project was government-funded, financial delays due to bureaucratic procedures caused interruptions in the contractor's payments, slowing progress. Second, the unavailability of original materials, particularly for the external floor finishes, required the contractor to use substitute materials that were not identical to the original but closely matched in appearance (Addis Ababa City Administration Cultural and Tourism Bureau, 2008). Despite these challenges, the restoration successfully preserved the historical, architectural, and functional value of the building.

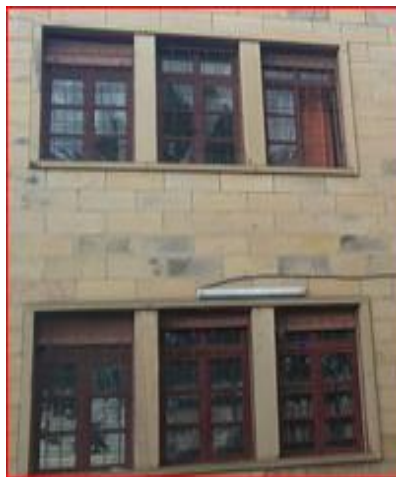
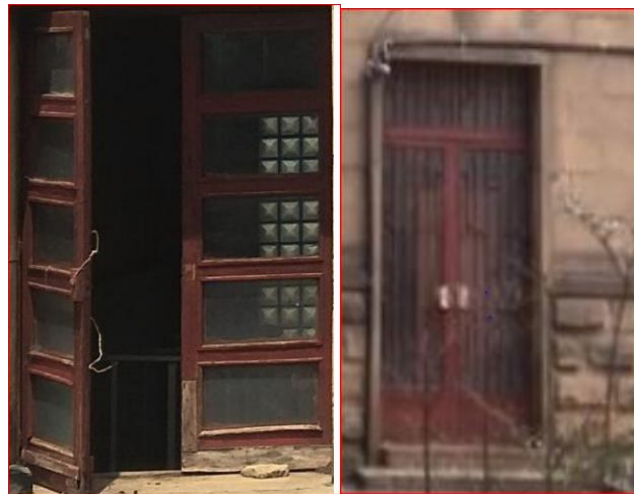
*Figure 14: Windows and doors of the building before restoration*

A). Deteriorated window of the building

B) Deteriorated doors of the building

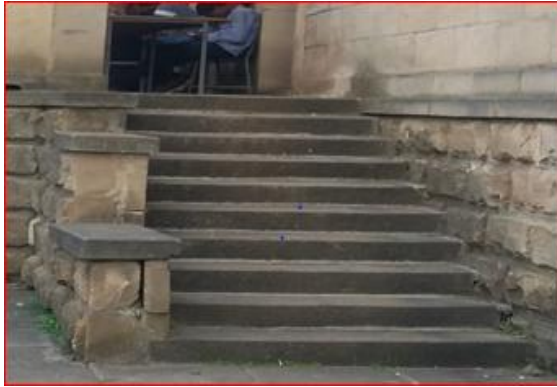
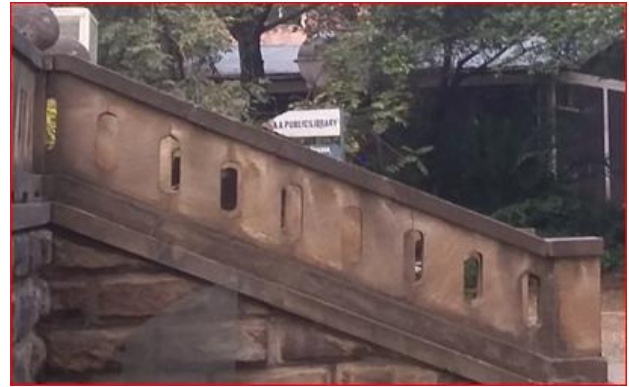
*Figure 15: Deteriorated external staircase*

A) Deteriorated Steps of the building

B) Deteriorated guard wall

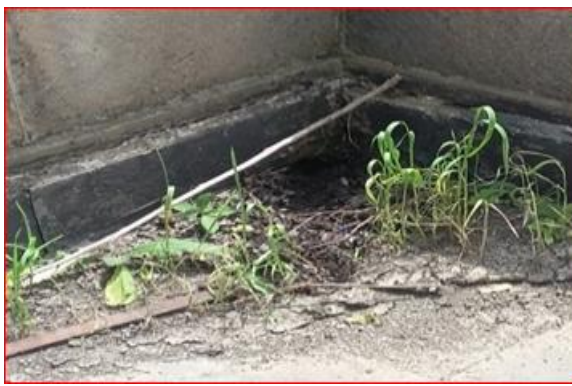
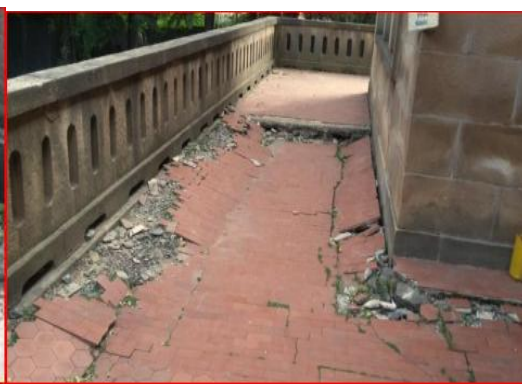
*Figure 16: Damaged roof slab and tile floor finish on verandas*

A) Growth of plants on the roof slab

**B) damaged tiles, floor finish on verandas**
