## Investigation of Conservation and Restoration Practices for Historical Buildings in Arada Sub-City, Addis Ababa, Ethiopia

### Abstract

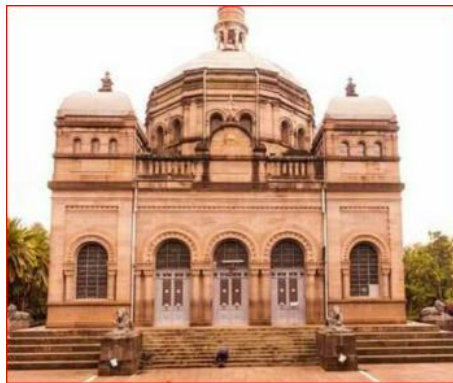
Figure 1. St. Taeka Nigist Be'ata Le Mariam church (Source; Alamy stock photo, 2020)

A) External part of the church

maintenance work was conducted on the roof 15 years ago, and the church was recorded as well-maintained in 2008 EC (Addis Ababa City Administration Cultural and Tourism Bureau, 2008). However, starting from 2010 EC, the church faced serious drainage problems, which caused water infiltration during the rainy season, leading to damp walls, growth of algae, and damage to materials in the basement museum (Alamy Stock Photo, 2020).

Restoration work began at the end of 2011 EC with a contract amount of 16.7 million ETB, involving Misac General Contractor, Fasil Giorgis Consultant, the Ethiopian Orthodox Church, and supervision by Addis Ababa City Administration Culture & Tourism Bureau. The restoration process involved cleaning and repainting walls, maintaining 16 steel-alloy doors, and covering broken windows with canvas paintings due to unavailability of original glass (Alamy Stock Photo, 2020). For example, the eight copper lion monuments and their supporting masonry walls were cleaned to remove corrosion, salt efflorescence, and fungal colonies, while cracks in the masonry were plastered, preserving their historical and cultural value. External and internal staircases were cleaned and repaired due to algae, fungi, and smoke damage. The top structures of the church, including the cross, crown, and cast-iron pillars, were heavily corroded because of poor drainage, requiring full restoration, welding, and repainting (Alamy Stock Photo, 2020).

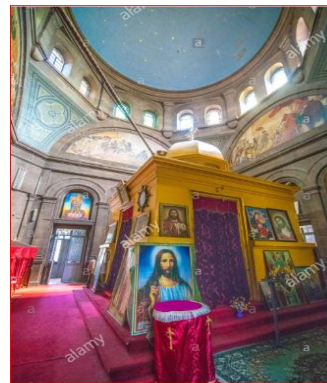
B) Internal part of the church

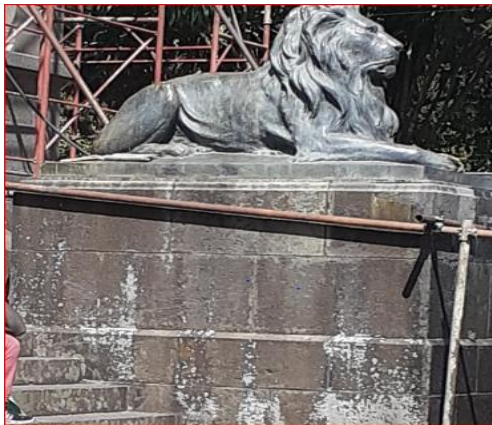
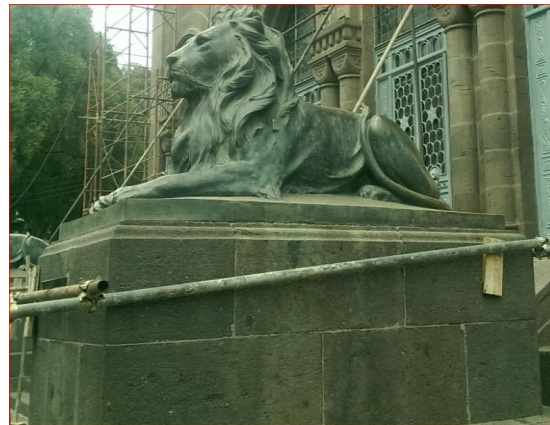
Figure 3. The status Lion monument with its support masonry wall

A) Lion monument before restoration work

B) Lion monument after restoration work

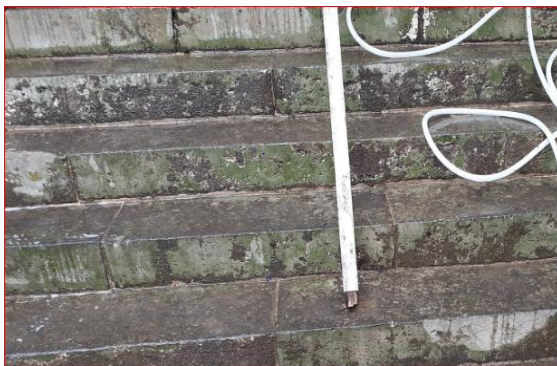
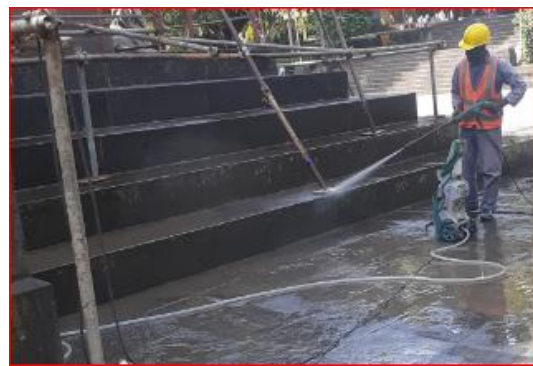
Figure 4. The status of the external staircase

A) Algae and fungi colony on external staircase

B) cleaning work on external staircase

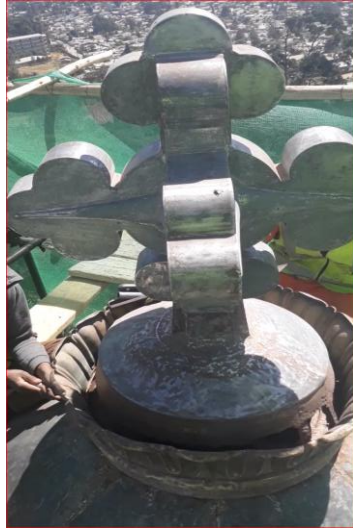
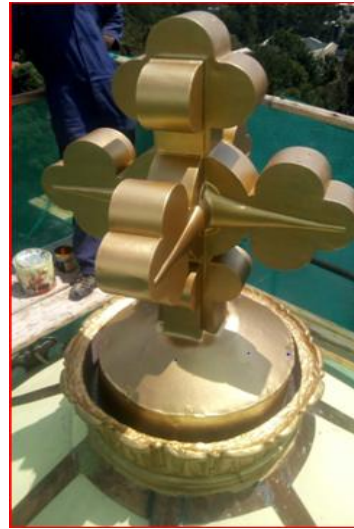
A) Deteriorated cross surface

B) painted cross surface

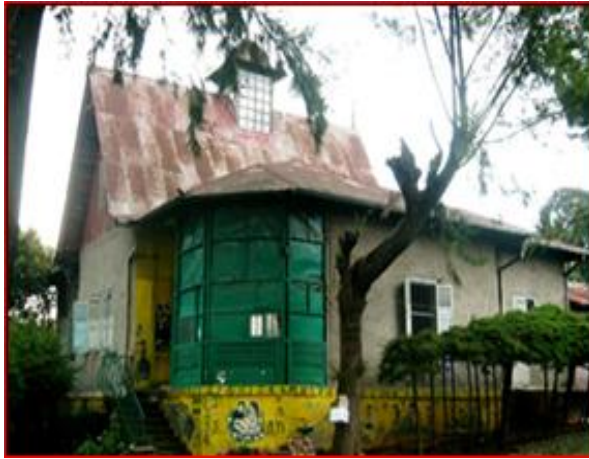
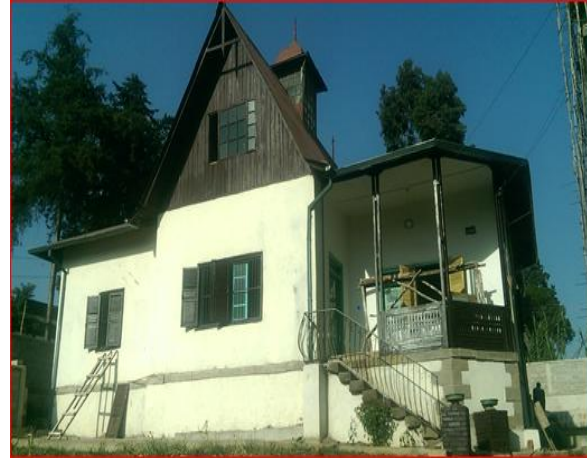
Figure 6. The status of Teshome Berhe Residence

A) External part of the building before restoration    B) External part of the building after

The conservation and restoration process involved a detailed assessment, which revealed severe deterioration of walls, roof, and flooring, while doors, windows, and window frames required minor maintenance. The walls, made of mud and wood, exhibited cracks and decay, particularly in the wooden ties. Restoration included replacing severely damaged wood, treating partially decayed wood with protective oil, and using a fermented mixture of red soil and lime to retain historical authenticity. Doors and windows were smoothed, painted, and had some locks replaced. The veranda guardrail, originally timber and glass, was restored with new timber while broken glass was removed but not replaced. The roof, including attic and pane windows, had corroded sheets and damaged timber trusses; restoration involved replacing roofing sheets, repairing trusses and attic walls, fixing the drainage system, and repainting the roof. Timber floors and external staircases were repaired or replaced and treated with protective oil, while the internal steel-and-timber staircase required only minor maintenance. Ceilings made of abujede were partially replaced and painted, lighting fixtures were restored, and historical bathroom fixtures

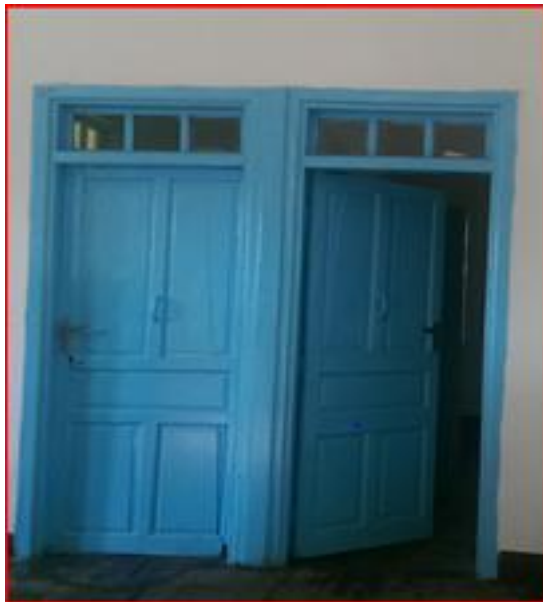
Figure 7. Doors and windows of the building after restoration work

A) Well Maintained door

B) well-maintained window

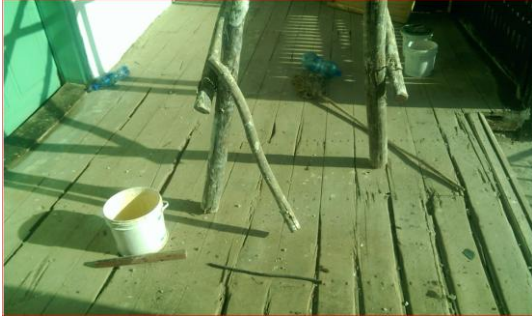
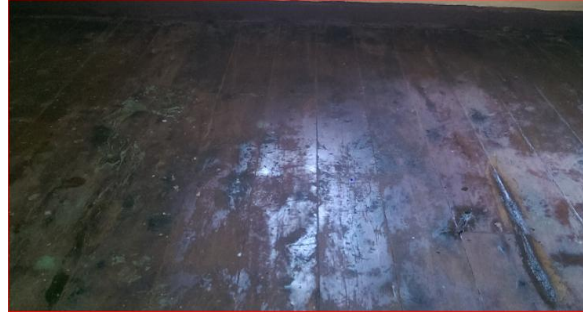
Figure 8. Timber floor finish before and after restoration work

A) Deteriorated floor finish

B) Well-maintained floor finish

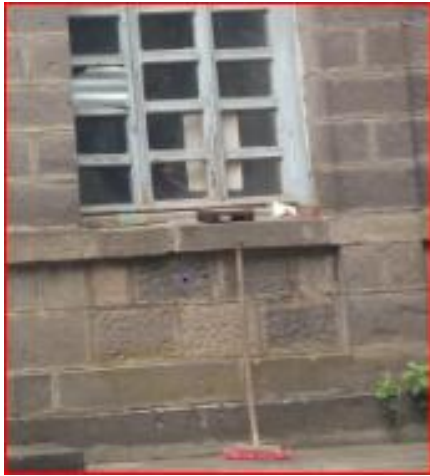
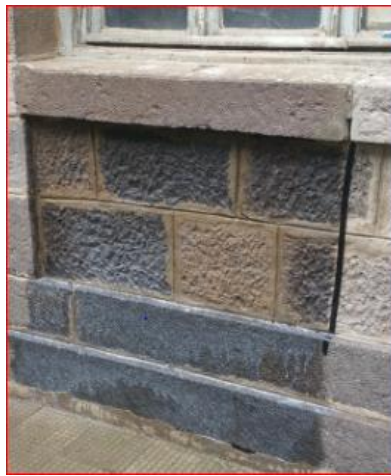
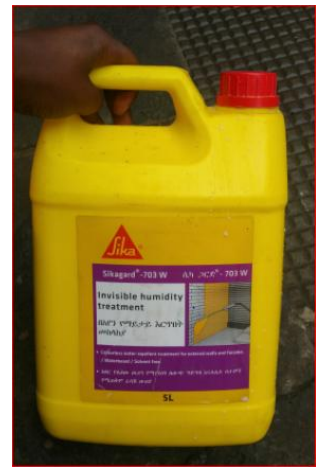
Figure 10. Status of the external wall and Sikagard chemical

A) Wall surface before restoration

B) painted wall surface

C) Sikagard chemical

The restoration process started with detailed investigation and research to identify the root causes of deterioration. The stone walls, affected by aging and algae/fungi growth, were partially reconstructed, cleaned with detergent, and treated with Sikagard chemical to improve water resistance and stain protection. Wooden doors and window frames, deteriorated due to dampness, aging, and insect activity, were repaired or replaced, and broken glass was substituted with new panes. The roof sheets were corroded and replaced to prevent water infiltration, and the brick-and-mortar chimney, which had developed cracks, was reconstructed and plastered (Figures 9–11).

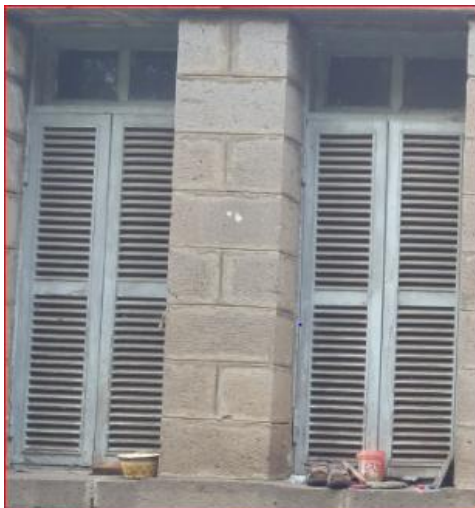
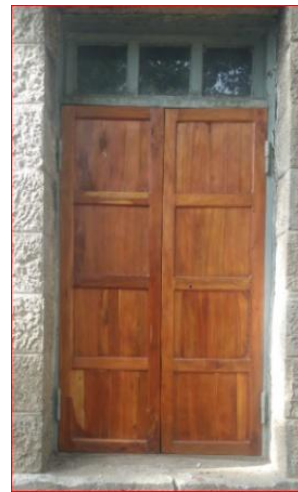
A) Deteriorated window frames

B) Windows of the building after maintenance

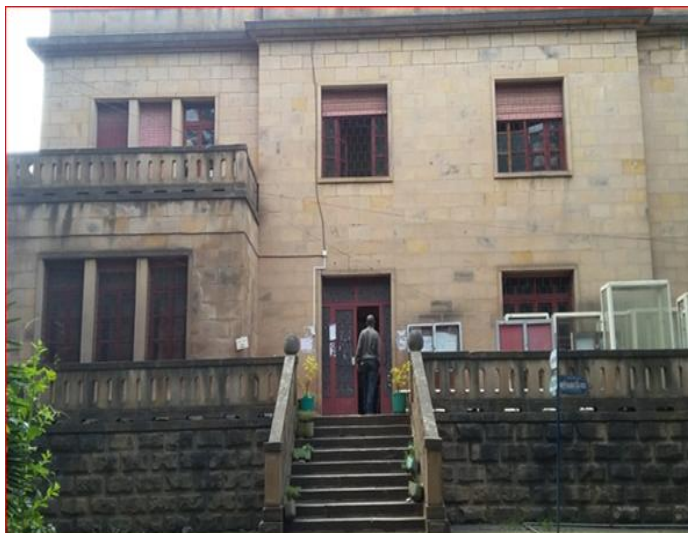
A) Front view of the building

Addis Ababa Library, Archives & Information Center is one of the earliest libraries in the capital, constructed at the end of the 19th century. It is located in Arada Sub-city, Wereda 06, around Sadist Kilo, between the Blind Association and Yekatit 12 Hospital. Currently owned by the Addis Ababa City Administration Culture & Tourism Bureau, the building serves as a public library and information center (Addis Ababa City Administration Cultural and Tourism Bureau, 2008). The G+1 structure has a rectangular plan and is entirely made of stone, featuring attractive slab roofs, balconies, and verandas. Over time, the building experienced significant deterioration due to man-made and environmental factors, including water leakage, loss of masonry, damaged slabs, and general wear. Restoration began in early 2012 EC with a total contract amount of 2.5 million ETB, involving Tewolde and Brhane Construction Work Partnership as the contractor, ARCCH as the consultant, and the city administration as the owner.

The restoration process included a comprehensive investigation and documentation by conservation experts from ARCCH. The walls, damaged by algae, fungi, missing render, efflorescence, and minor cracks, were cleaned, repaired, and repointed. Internal walls affected by roof leakage were dismantled, re-plastered with gypsum, and painted. Metal and wooden doors and windows, deteriorated due to aging, dampness, and insect activity, were repaired or replaced, and broken glass and missing locks were restored. External stone staircases affected by algae growth and minor cracks were washed and repointed. The slab roof, a major source of internal dampness, underwent extensive restoration: damaged tiles were removed, a waterproof membrane applied, and tiles reinstalled. Internal timber and marble floors, damaged due to uneven load distribution, were replaced or repaired, while external floor finishes on balconies and verandas were entirely replaced with nearly identical materials (Figures 12–16).

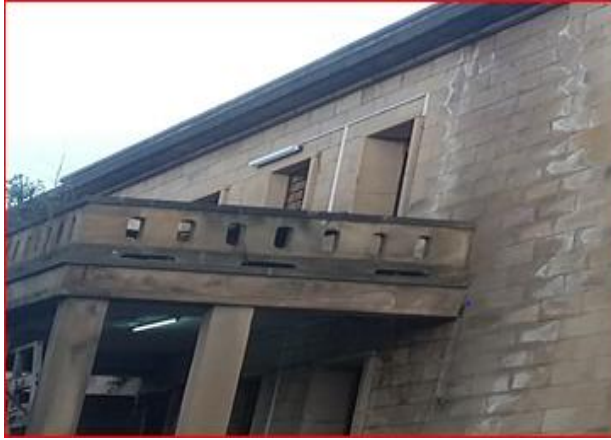
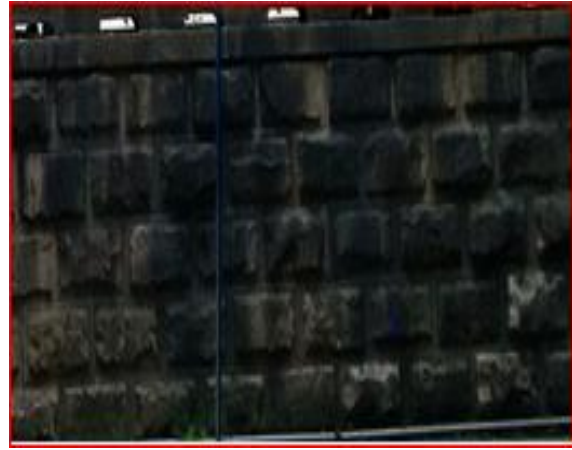
Figure 13. Deteriorated external wall surface

A) Efflorescence effect on the surface of the wall    B) Algae colony on external wall surface

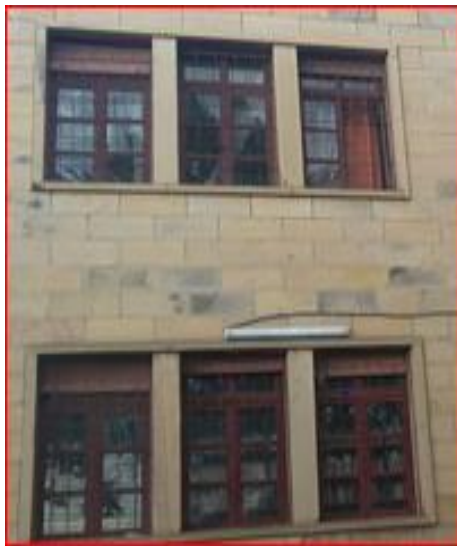
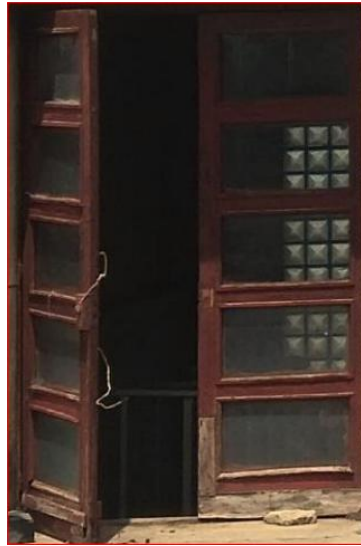
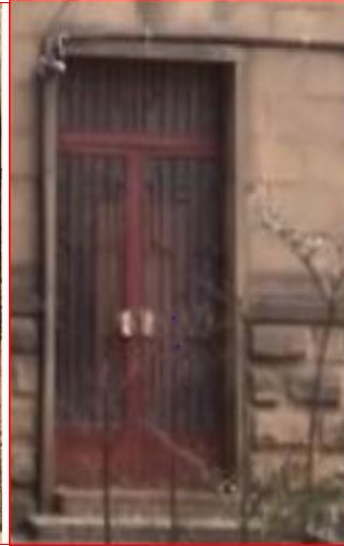
Figure 14. Windows and doors of the building before restoration

A). Deteriorated window of the building    B) Deteriorated doors of the building

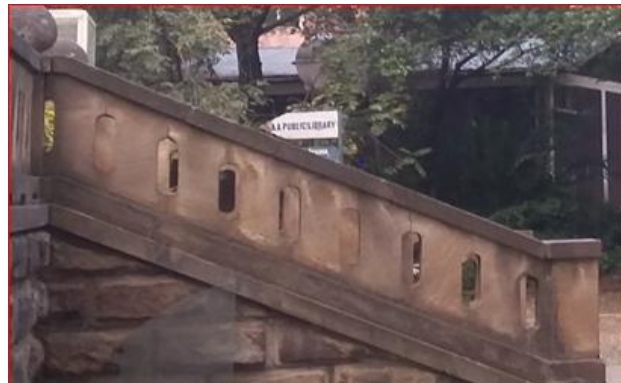
Figure 15. Deteriorated external staircase

A) Deteriorated Steps of the building

B) Deteriorated guard wall

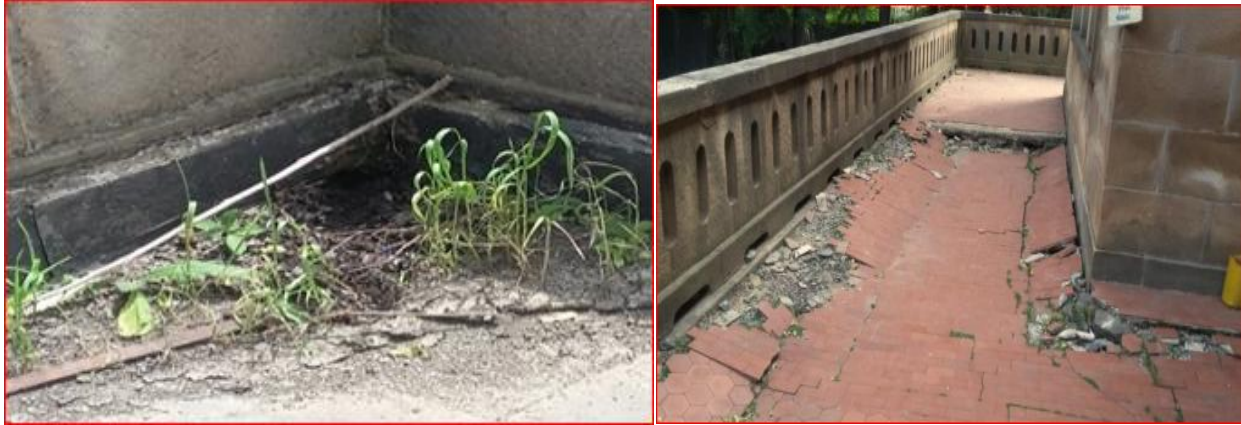
Figure 16. Damaged roof slab and tile floor finish on verandas

A) Growth of plants on the roof slab

B) Damaged tiles, floor finish on verandas
