Assessment of Deferred Maintenance Impacts on Flexible Pavements in Hawassa City and Countermeasure Strategies Using the HDM-4 Mode

Tigist Assefa*, Beza Abireham, Bitseat Zeleke, Erste Telila, & Temesgen Aynabeba

Department of Civil Engineering, Institute of Technology, Hawassa University, Hawassa, Ethiopia.

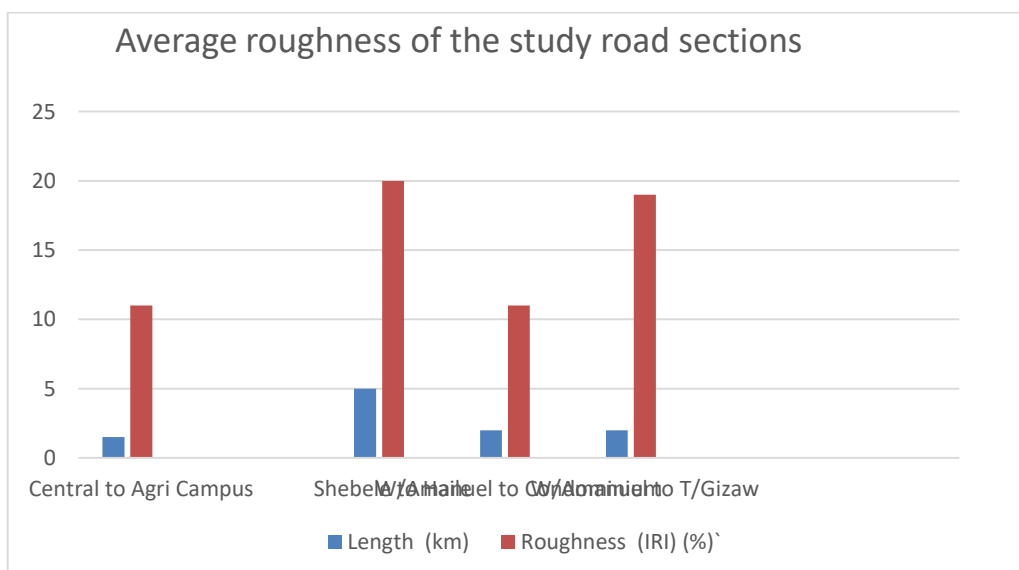
Figure 4. Average roughness of the study road sections.

The Average roughness (IRI) of the study route from central to Agriculture Campus and weldeamanuel to condominium (11%) is fair whereas Shebele to Haile (20%) is very poor, Weldamanuel to Tesfaye Gizaw (19%) is in poor condition (Fig. 4)

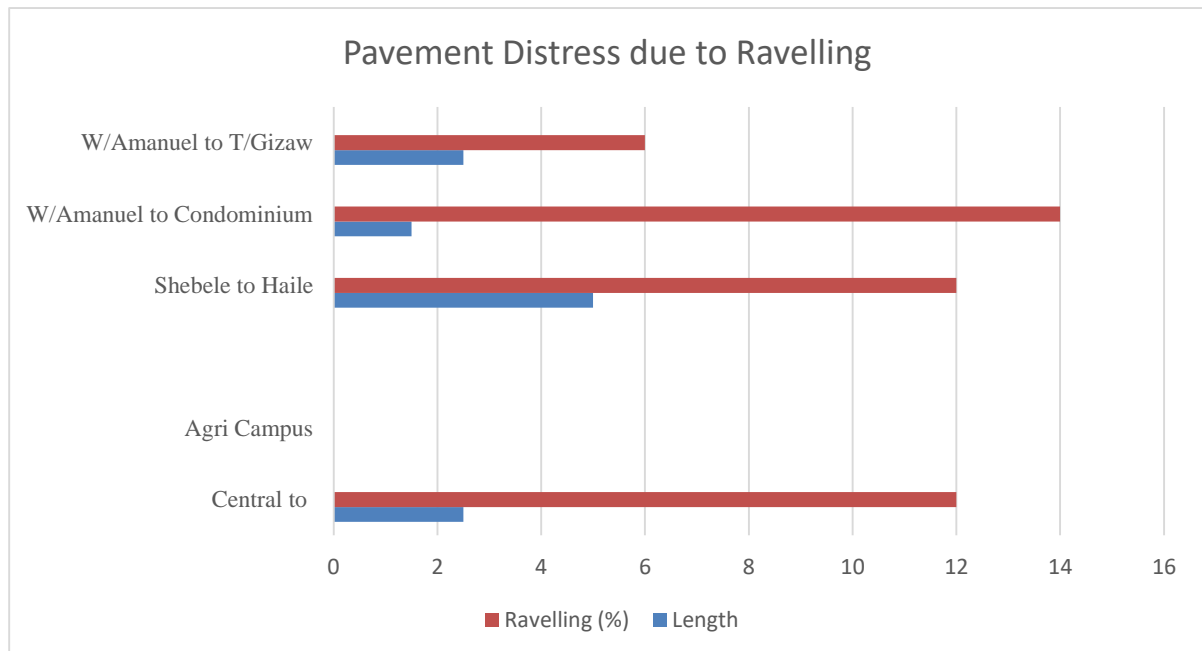
Figure 5. Pavement distress due to raveling

The study road from central to Agriculture, Shebele to Haile resorts and weldeamanuel to Condominium raveling is in warning condition and in the other way the route from weldamanuel to Tesfaye Gizaw is on moderate condition (Fig. 5)

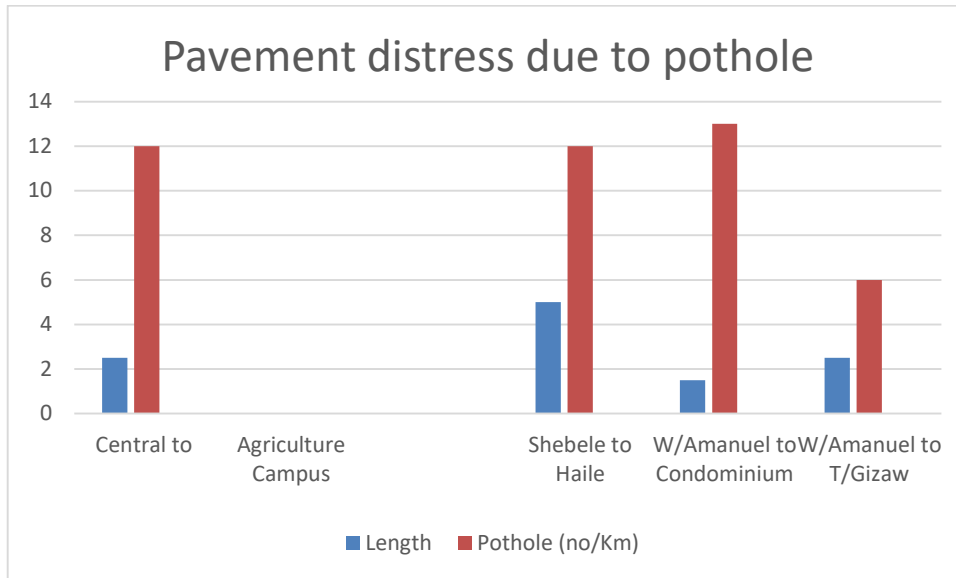
Figure 6. Pavement distress due to pothole

The Pothole numbers per kilometer from Central to Agriculture Campus, Shebele to Haile and Weldamanuel to Condominium (12 to 13%) is in warning condition Weldamanuel to Tesfaye Gizaw (6%) is on Moderate condition.

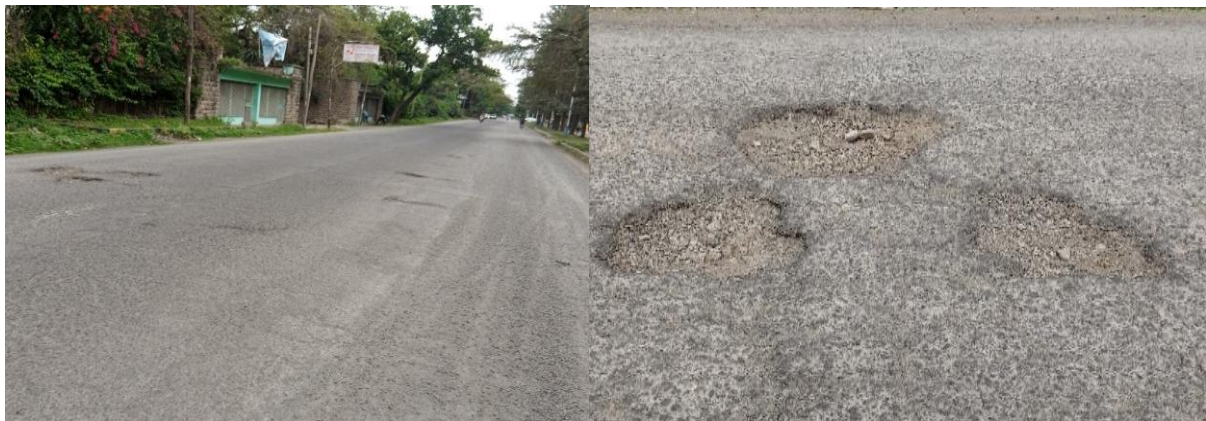
The types of pavement distresses that were observed during the research are alligator cracking, Block cracking, potholes, lacy edge, patching and raveling some of them types are presented below from Figure 4.1

Figure 8. (a) Raveling (b) Pathole
