## Cause of Failure Investigation of Masonry Retaining Walls at Logita Bridge Site, Sidama Southern Ethiopia

*A masonry retaining wall supporting the approach embankment of Logita Bridge suffered significant distresses, which led to a dispute between the client, the consultant, and the contractor. As a result, the construction work has been interrupted for a prolonged time causing frustration on all stakeholders. This paper presents the investigation work undertaken to establish the causes of the observed distresses. Based on preliminary investigations, a hypothesis was developed that the observed distresses were due to the choice of ambiguous structural system, use of materials with widely varying stiffness and the sole use of standard stability checks, which failed to verify the complex design. A numerical simulation was undertaken using FLAC 8.1 by assuming elastic behavior for the reinforced concrete and stone masonry parts of the wall and Mohr-Coulomb model for the various backfill materials and foundation. The values of parameters were either adopted directly from code provisions or were estimated using methods specified in relevant codes. The modeling was undertaken for the

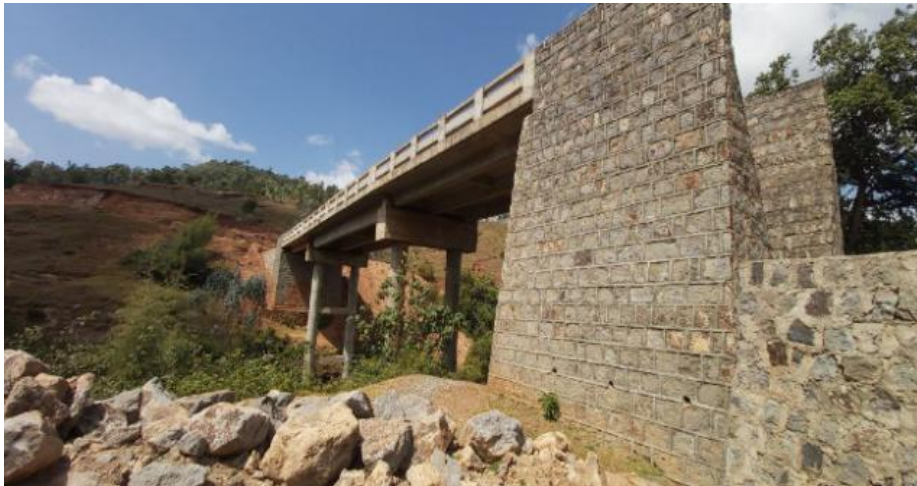
Figure 2. Partial View of Logita Bridge, abutment and approach embankment retaining wall under construction

The bridge site is located at  $6^{\circ} 30' 11.86''$  N and  $38^{\circ} 49' 25.43''$  E on Bansa Ware – Mikichu road project. Girder beams support bridge deck, which in turn is supported by piers and masonry abutments on the East and West sides. Unreinforced, natural stone with ordinary mortar, masonry ‘gravity’ walls on both sides of the roads support the approach embankment. The walls extend longitudinally up 20 m and have height up to 15 m. In order to address the relatively high elevation 15 m at its highest point, the designer has chosen a structural system, which appears to be cascading/stacked walls (Figure 2).

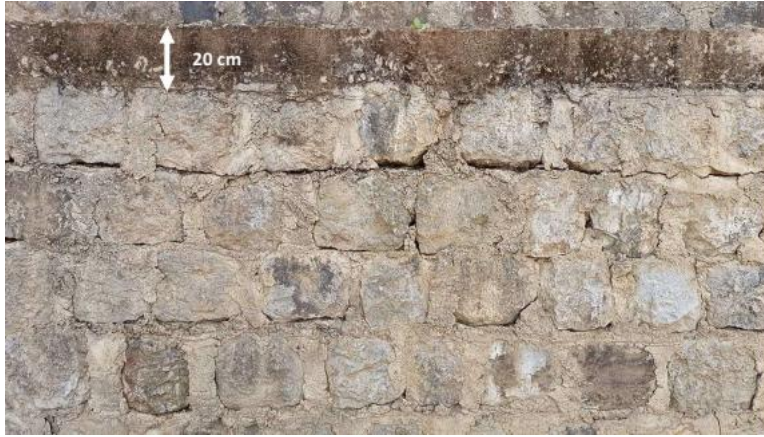
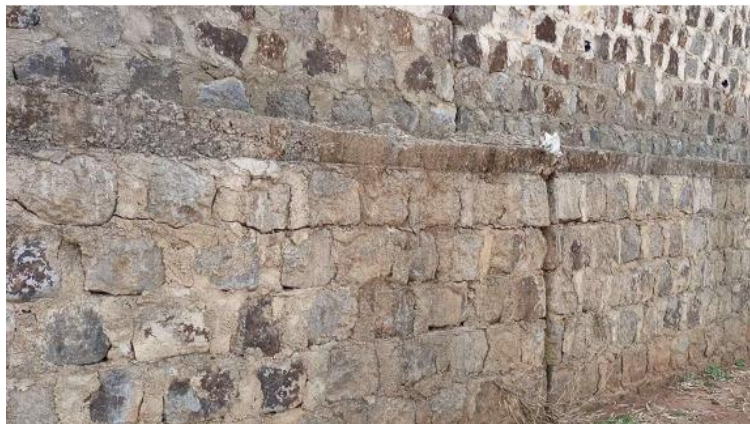
Although the authors did not verify by measurements (i.e. a direct comparison between design spatial orientation and current orientation of the wall), physical inspections shows no sign of stability failure i.e. failure due to toppling, sliding or bearing capacity (excessive settlement or nearby budging due to foundation movement). Figure 4 (a) and (b) showed pictures of the horizontal cracks observed at the bridge site. After these distresses were observed, construction of the retaining wall has been stopped after the second layer is back filled.

Figure 4. (a) Horizontal Cracks South Side (b) Horizontal cracks & Vertical Construction Joint South Side

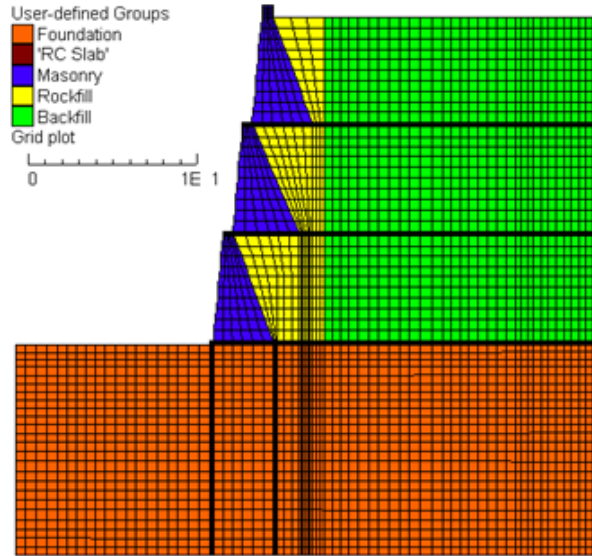
Figure 6. Finite Difference Model Logita –Design

The Logita bridge approach retaining wall is modeled using FLAC to analyze the stress state under the current level of construction (As-Is) and the designing lay out for the most critical profile of 15 m height. A 30 m by 36 m extent is used to model the retaining wall to ensure boundary conditions do not affect the analysis. Fixed boundary is used at the bottom and roller support is used on the sides of the model. Automatically generated course mesh is used to compute the internal stress and deformations. Figure 5 and 6 showed the models generated for the Logita-AsIs and Logita-Design scenarios along with the finite element grids respectively.

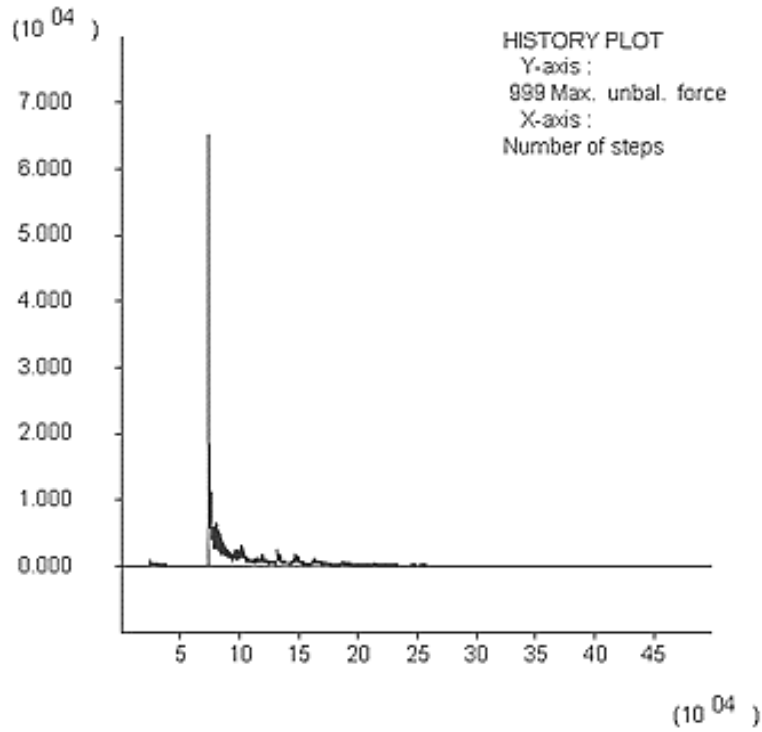
In FLAC, a quick indicator of the computation status is the 'unbalanced force' value, the maximum nodal force vector. If the unbalanced force reaches a zero value, the computation stops as the systems has reached a static equilibrium. However, if the unbalanced force converges to none zero value, the system is flowing with constant velocity i.e. failure has occurred. In the analysis of the Logita bridge approach embankment, the system reached static equilibrium for the Logita-AsIs (Figure 7).

Figure 7. History Plot of Unbalanced for Logita As-Is

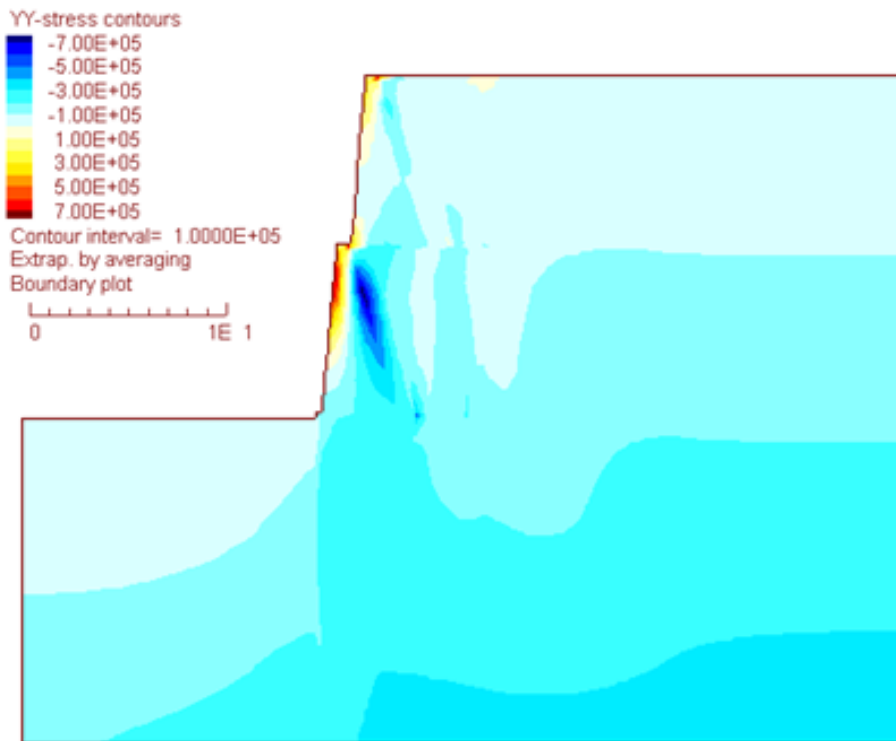
The total vertical stress values are the preferred indicator to determine the cause of the distress observed on Logita retaining wall. In FLAC the sign convention is the compressive stress are negative and tensile stress are positive. The computation results for the two cases indicate the development of tensile stress at the face of the wall where horizontal cracks are observed. The range of magnitudes for the Logita-AsIs is case 0.5 - 0.7 MPa (Figure 8). The total shear strain is a preferred indicator for movement within the model due to the prescribed loading. Figure 9 presented the total straining increment plot for Logita-AsIs.

Figure 8. Total Vertical Stress Plot for Logita As-Is

The numerical analysis conclusively proves that the observed distress are caused by development of tensile internal stresses at the face of the wall. If the final wall is constructed, the numerical simulation indicates that wall will collapse, not necessarily from stability of the wall but through deep-seated stability failure through the backfill and foundation.

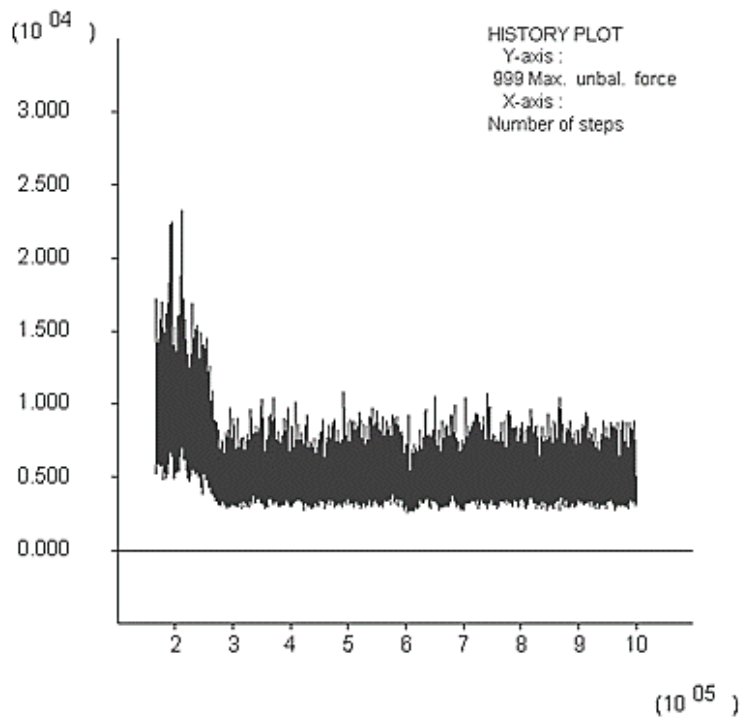
For the final design scenario, Logita–Design case the model’s unbalanced force ratio did not converge to a zero value after  $10^6$  steps (Figure 10).

Figure 10. Unbalance force History plot for Logita-Design

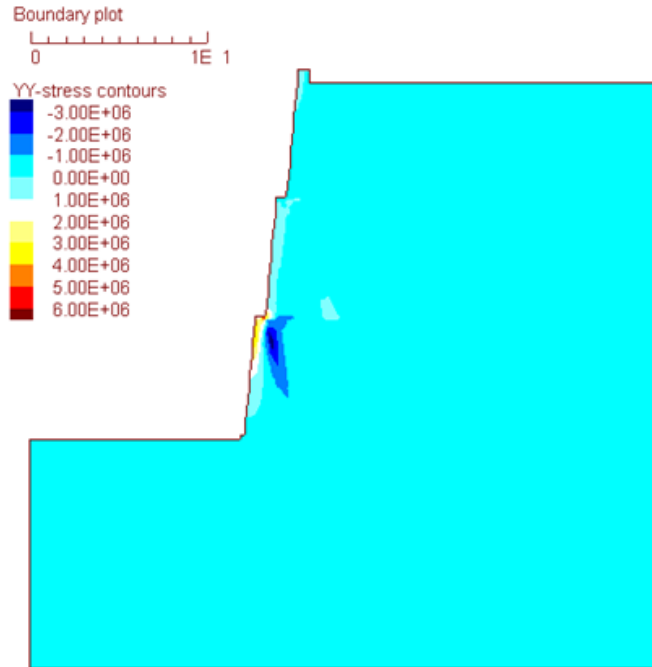
Figure 11. Total Vertical Stress plot for Logita-Design

The range of magnitudes vertical tensile stress for Logita-Design is 3-4 MPa (Figure 11). Masonry wall is not expected to support tensile stress, and hence the cracks on the face of the wall and potential failure for the final design of constructed.

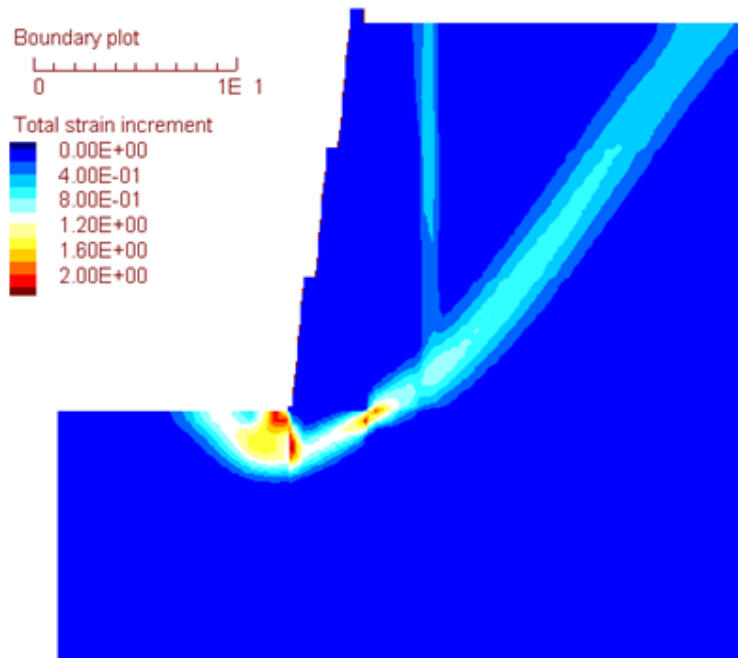
Figure 12. Total Strain Plot for Logita-Design

The major observation on the total strain plot shall be the potential for deep-seated failure through the granular back fill of the final design, if it were to be constructed (Figure 12). Of course, this is a function of the assumed foundation conditions.

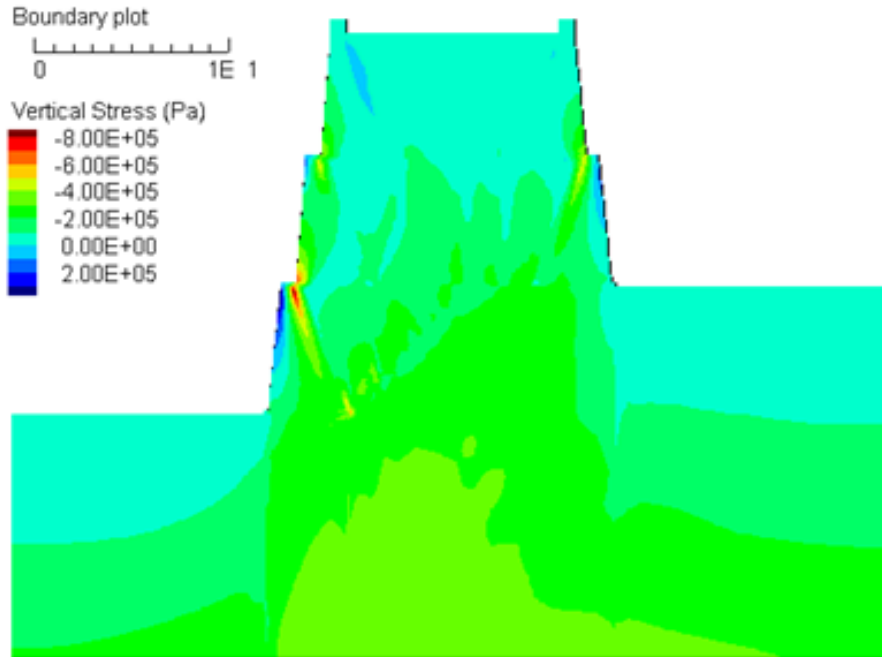
Figure 14. Total Vertical Stress Plot for Previously Recommended Solution

The replacement of the back fill material with a rock fill appears to avoid the potential deep-seated failure within the supported soil mass. Furthermore, the extension of the RC slab across the roadway section reduces but does not remove the development of tensile stresses at the face of the retaining wall.

Some of the previously proposed solution such as replacing the backfill with a rock fill and extending the reinforced concrete slab across the road section do not fundamentally address the design shortfalls. These may address the potential failure due to plastic flow within the backfill, but fail to address the tension cracks on the face of the wall. It is worth noting that the reinforced concrete is not design for the proposed new loading condition and its response is unknown.

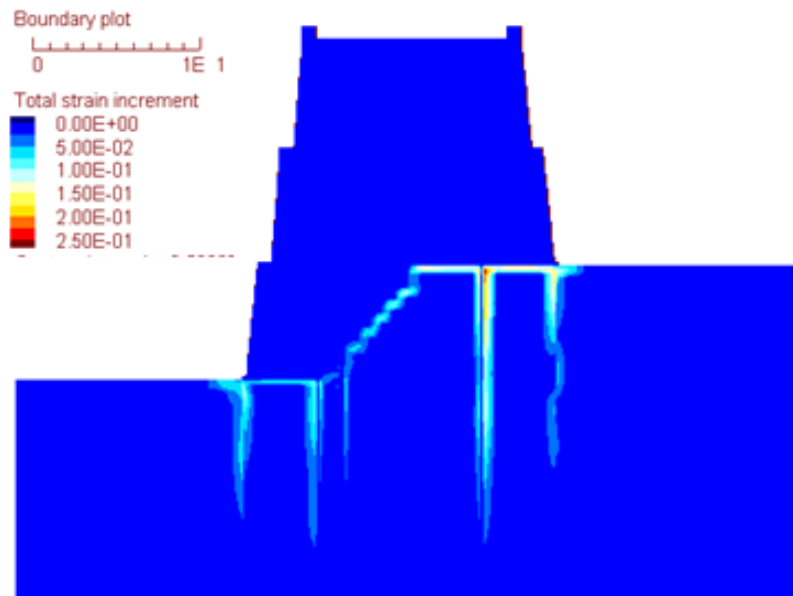
Figure 15. Total Strain Plot for Previously Recommended Solution

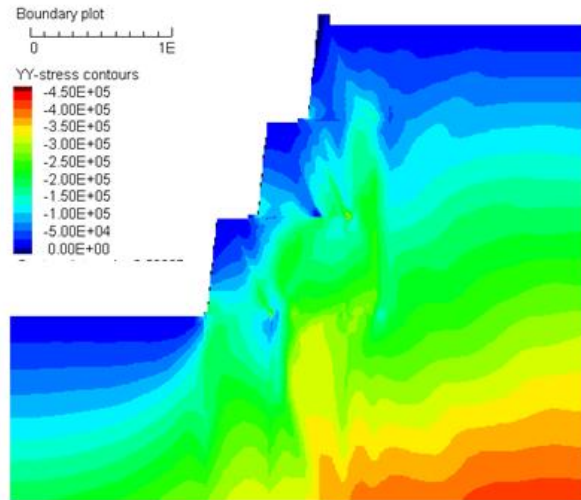
At Logita Bridge, approach embankment although there is an offset of 0.5 m between the masonry walls. The foundation of the subsequent wall, however, does not have any offsets. The authors of this report simulated introduction of such an offset to evaluate the possibility of reducing the tensile stress on the face of the wall. Figure 17 shows the effect of cascading the walls by 1.0.

Figure 17. Total Vertical Stress Plot for 1 m offset Logita-Design

The above analysis shows offsetting the top wall from the head of the bottom wall in fact eliminates tensile stresses from the face of the wall. Weight (2008) identified a jump in factor of safety after the offset distance passes the point above the heel of the bottom wall. However, his modeled used cantilever retaining walls.
