Cause of Failure Investigation of Masonry Retaining Walls at Logita Bridge Site, Sidama Southern Ethiopia

Bereket Bezabih¹, Henok Refissa, Thomas Bezabih

¹*Lecturer, Department of Civil Engineering, Hawassa Institute of Technology, Hawassa, Ethiopia*
E-mail: bereket.bezabih@hu.edu.et Phone +251994783890

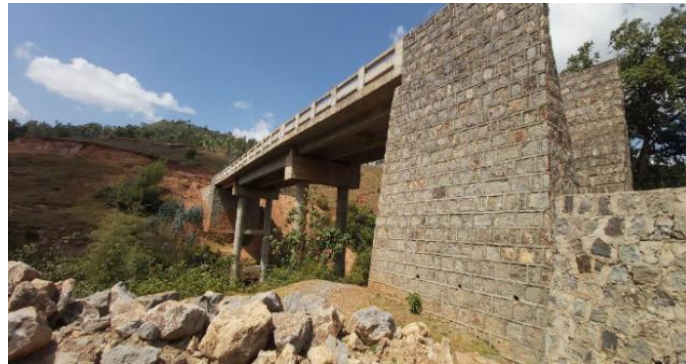
Figure 2 Partial View of Logita Bridge, abutment and approach embankment retaining wall under construction

The bridge site is located at $6^{\circ} 30' 11.86''$ N and $38^{\circ} 49' 25.43''$ E on Bansa Ware – Mikichu road project. Girder beams support bridge deck, which in turn is supported by piers and masonry abutments on the East and West sides. Unreinforced, natural stone with ordinary mortar, masonry ‘gravity’ walls on both sides of the roads support the approach embankment. The walls extend longitudinally up 20 m and have height up to 15 m. In order to address the relatively high elevation 15 m at its highest point, the designer has chosen a structural system, which appears to be cascading/stacked walls, see Figure 3.

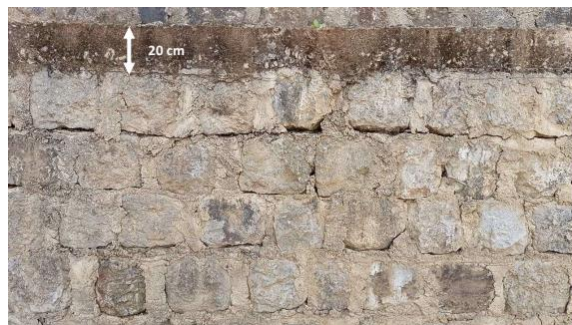
Although the authors did not verify by measurements (i.e. a direct comparison between design spatial orientation and current orientation of the wall), physical inspections shows no sign of stability failure i.e. failure due to toppling, sliding or bearing capacity (excessive settlement or nearby budging due to foundation movement). Figure 4 (a) and (b) show pictures of the horizontal cracks observed at the bridge site. After these distresses were observed, construction of the retaining wall has been stopped after the second layer is back filled.

Figure 4 (a) Horizontal Cracks South Side (b) Horizontal cracks & Vertical Construction Joint South Side
