Investigation of Conservation and Restoration Practices for Historical Buildings in Arada Sub-City, Addis Ababa, Ethiopia

Tariku Nigussie[1,*], Abebe Dinku[2] and Hamere Teshome[3]

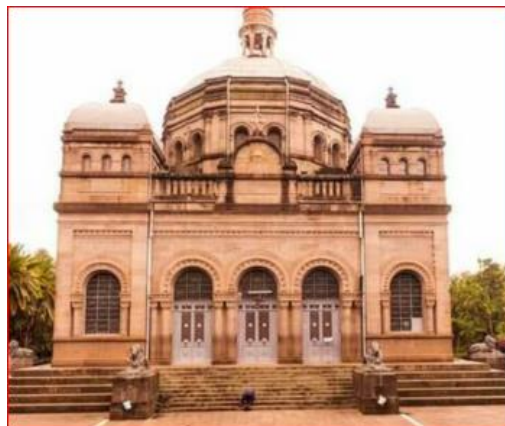
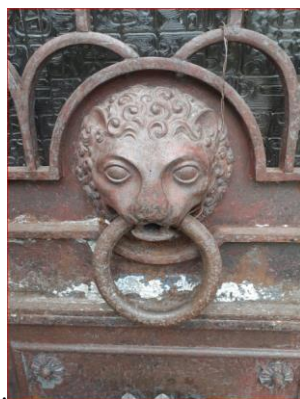
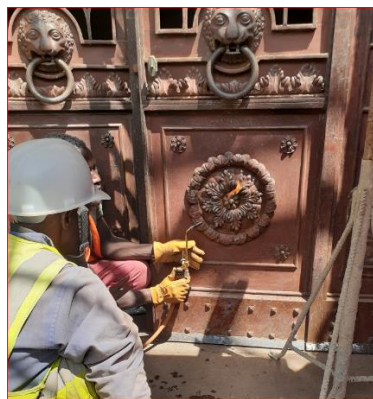
Restoration work began at the end of 2011 EC with a contract amount of 16.7 million ETB, involving Misac General Contractor, Fasil Giorgis Consultant, the Ethiopian Orthodox Church, and supervision by Addis Ababa City Administration Culture & Tourism Bureau. The restoration process involved cleaning and repainting walls, maintaining 16 steel-alloy doors, and covering broken windows with canvas paintings due to unavailability of original glass (Alamy Stock Photo, 2020). For example, the eight copper lion monuments and their supporting masonry walls were cleaned to remove corrosion, salt efflorescence, and fungal colonies, while cracks in the masonry were plastered, preserving their historical and cultural value. External and internal staircases were cleaned and repaired due to algae, fungi, and smoke damage. The

top structures of the church, including the cross, crown, and cast-iron pillars, were heavily corroded because of poor drainage, requiring full restoration, welding, and repainting (Alamy Stock Photo, 2020).

A) External part of the church   B) Internal part of the church
Figure 1: St. Taeka Nigist Be'ata Le Mariam church (source; Alamy stock photo, 2020)

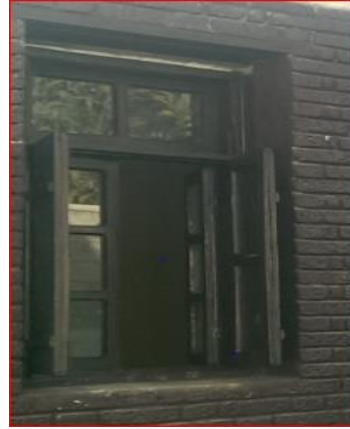
Figure 6: The status of Teshome Berhe Residence

Teshome Berhe Residence, located in Arada Sub City, Kebele 11 along Adawa Street, was constructed in the 1930s and is currently owned by the government, serving as Htsanalem Public School (Addis Ababa City Administration Cultural and Tourism Bureau, 2008). The building features a small tower with a decorative roof and small pane windows. Over time, structural deterioration due to aging, weathering, termite activity, and poor drainage put the

The conservation and restoration process involved a detailed assessment, which revealed severe deterioration of walls, roof, and flooring, while doors, windows, and window frames required minor maintenance. The walls, made of mud and wood, exhibited cracks and decay, particularly in the wooden ties. Restoration included replacing severely damaged wood, treating partially decayed wood with protective oil, and using a fermented mixture of red soil and lime to retain historical authenticity. Doors and windows were smoothed, painted, and had some locks replaced. The veranda guardrail, originally timber and glass, was restored with new timber while broken glass was removed but not replaced. The roof, including attic and pane windows, had corroded sheets and damaged timber trusses; restoration involved replacing roofing sheets, repairing trusses and attic walls, fixing the drainage system, and repainting the roof. Timber floors and external staircases were repaired or replaced and treated with protective oil, while the internal steel-and-timber staircase required only minor maintenance. Ceilings made of abujede were partially replaced and painted, lighting fixtures were restored, and historical bathroom fixtures were cleaned and preserved to maintain authenticity. Several major challenges were encountered during the restoration. The unavailability of original materials, particularly thick roofing sheets, made it difficult to match historical specifications. Financial constraints affected the project, including delayed contractor payments and issues with additional work costs. Additionally, incomplete drawings and specifications posed difficulties during restoration, requiring careful judgment to maintain the building's historical and structural integrity. Despite these challenges, the project successfully preserved the originality and historical value of the residence, as illustrated in Figures 6 to 8, which show the building before and after restoration.

A) External part of the building before restoration   B) External part of the building after

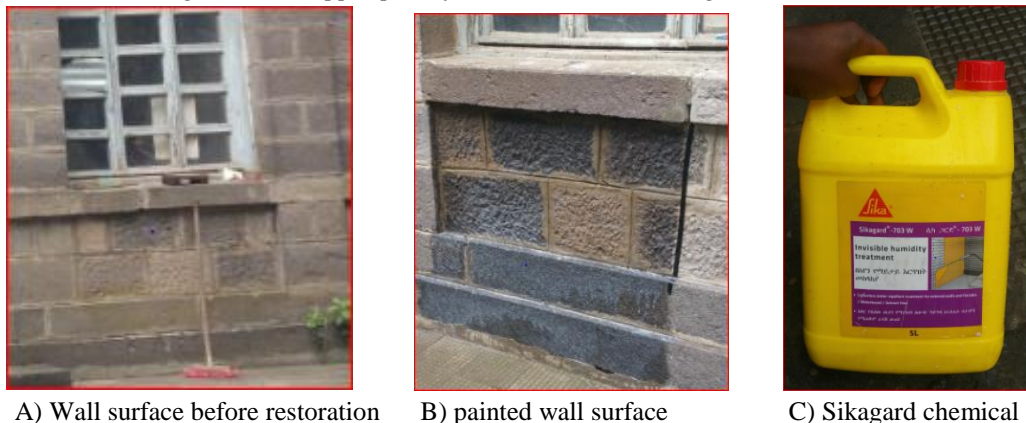
Figure 10: Status of the external wall and Sikagard chemical

The restoration process started with detailed investigation and research to identify the root causes of deterioration. The stone walls, affected by aging and algae/fungi growth, were partially reconstructed, cleaned with detergent, and treated with Sikagard chemical to improve water resistance and stain protection. Wooden doors and window frames, deteriorated due to dampness, aging, and insect activity, were repaired or replaced, and broken glass was

A) Wall surface before restoration   B) painted wall surface   C) Sikagard chemical

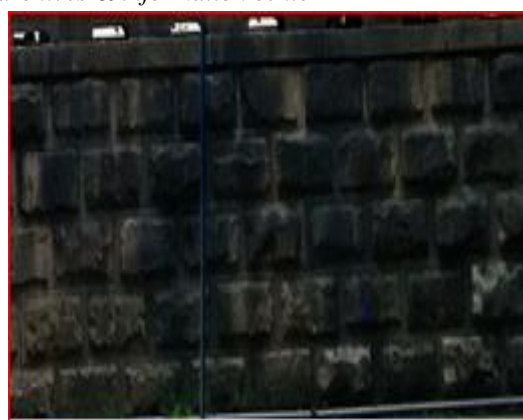
Figure 12: Addis Ababa library archives & information center

The restoration process included a comprehensive investigation and documentation by conservation experts from ARCCH. The walls, damaged by algae, fungi, missing render, efflorescence, and minor cracks, were cleaned, repaired, and repointed. Internal walls affected by roof leakage were dismantled, re-plastered with gypsum, and painted. Metal and wooden doors and windows, deteriorated due to aging, dampness, and insect activity, were repaired or replaced, and broken glass and missing locks were restored. External stone staircases affected by algae growth and minor cracks were washed and repointed. The slab roof, a major source of internal dampness, underwent extensive restoration: damaged tiles were removed, a waterproof membrane applied, and tiles reinstalled. Internal timber and marble floors, damaged due to uneven load distribution, were replaced or repaired, while external floor finishes on balconies and verandas were entirely replaced with nearly identical materials (Figures 12–16). Two major challenges were observed during the restoration. First, although the project was government-funded, financial delays due to bureaucratic procedures caused interruptions in the contractor's payments, slowing progress. Second, the unavailability of original materials, particularly for the external floor finishes, required the contractor to use substitute materials that were not identical to the original but closely matched in appearance (Addis Ababa City Administration Cultural and Tourism Bureau, 2008). Despite these challenges, the restoration successfully preserved the historical, architectural, and functional value of the building.

| A) Front view of the building | B) Side view of the building |
